Received: 17/03/2024

Accepted: 23/04/2024

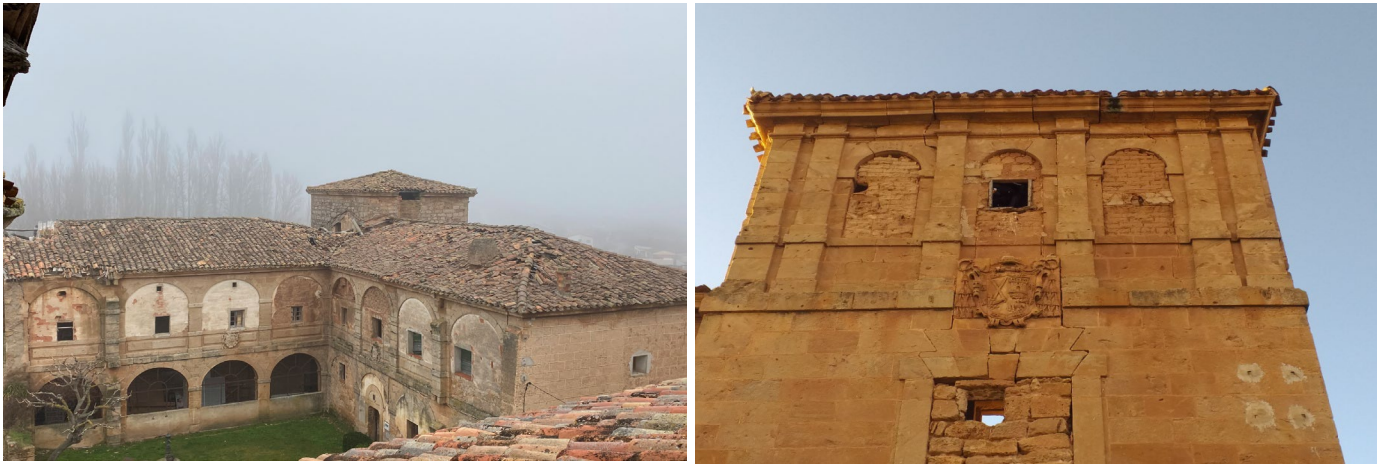
Fig. 1 and 2: Views of the building, and of the Tower. (Source: Paula Montoya Saiz)

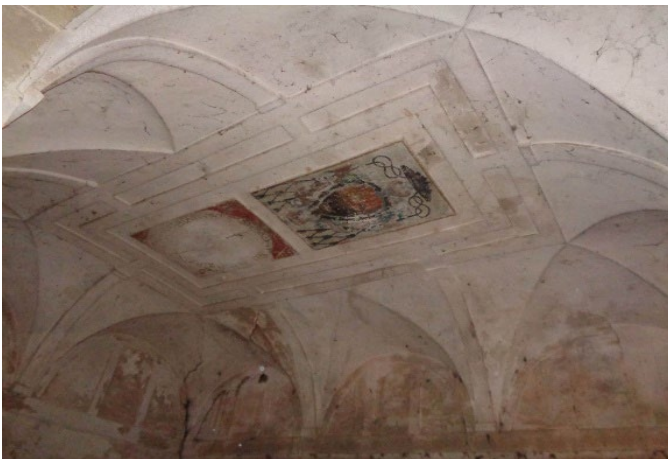
Fig. 3: Partitioned vaults over the main staircase. (Source: Imanol Ruiz de Vergara Ruiz de Azúa)

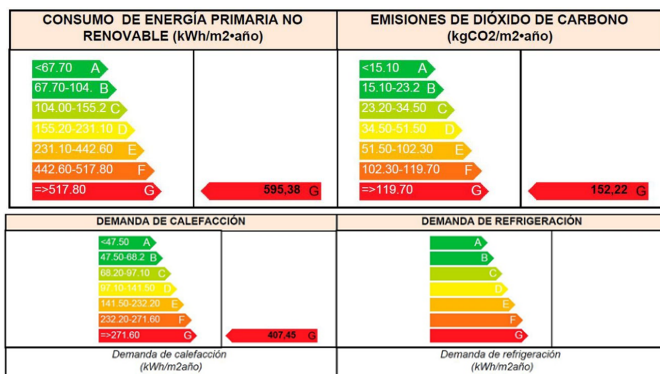
Fig. 14: Energy Performance Certificate of the building in its current state. (Source: Raúl Briones Llorente)

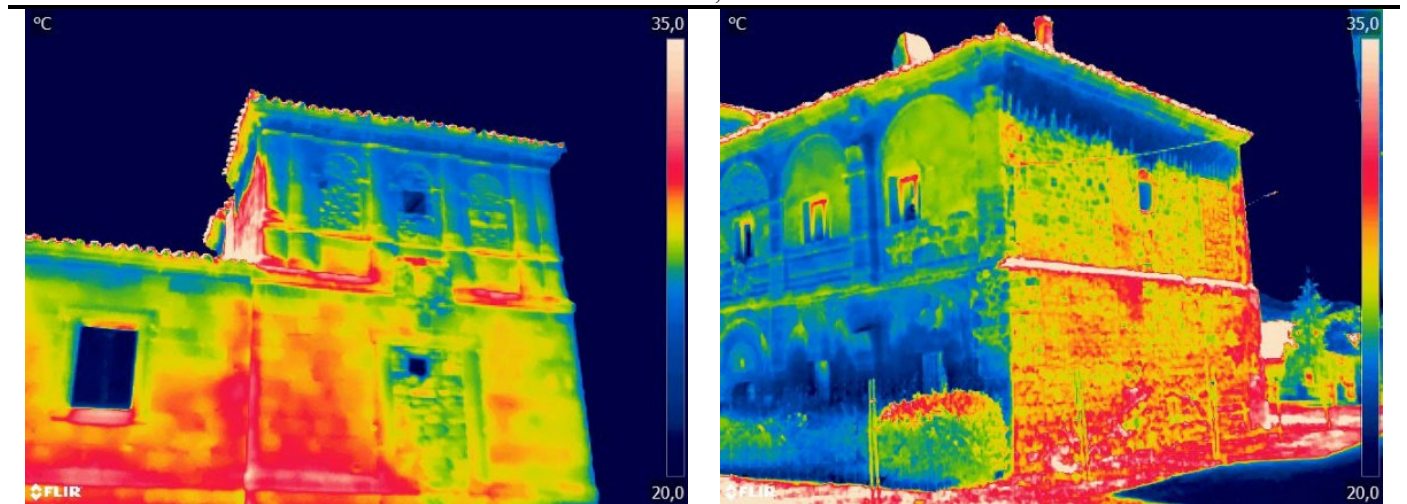
Fig. 15: Infrared thermographs of the Tower and the South body in their current state. (Source: Imanol Ruiz de Vergara Ruiz de Azúa)

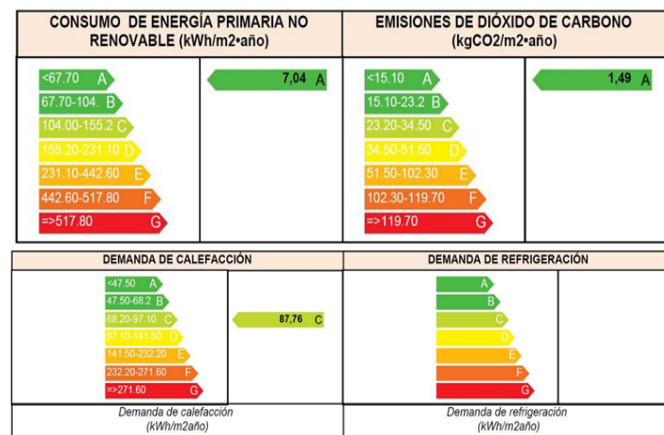
Fig. 14: Energy Performance Certificate of the building in its current state. (Source: Raúl Briones Llorente)
