## Proyecto de rehabilitación para uso residencial de la antigua abadía de salas de Bureba (Burgos) Rehabilitation project for residential use of the old abbey of salas de Bureba (Burgos)

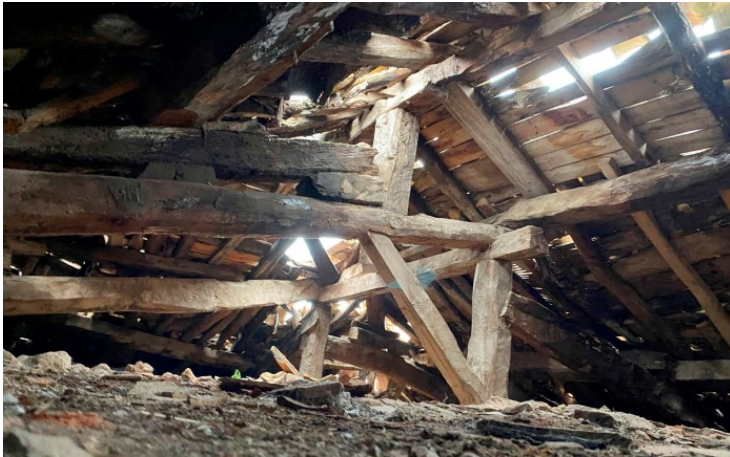
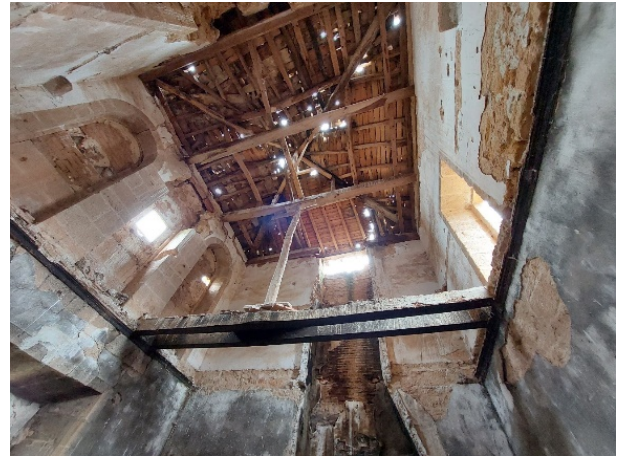
Fig. 3. Wooden structure of the sloping roofs and interior of the body of the Tower. (Source: Paula Montoya Saiz)

It is estimated that the roof is built on hipped slopes with solid wood beams, the covering element is completed with pairs and shingles on which there are tiles placed in the traditional style, without receiving. It is observed that there is no clear system of trusses, having built a precarious structure to support the inclined beams, as can be seen in Fig. 3.

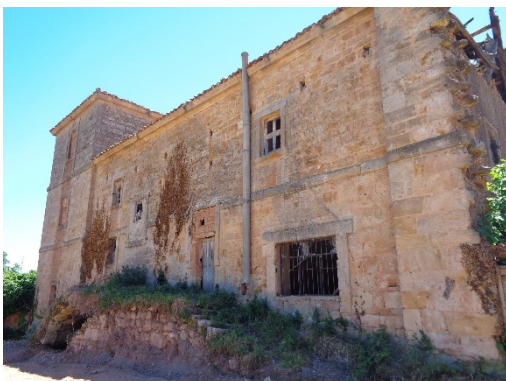
The front wall at the west end has an unfinished roof finish with a wall element of plastering, as if it had intended to extend the building on that side, as can be seen in Fig. 4.

Fig. 4. North façade with Tower and West headwall. (Source: Imanol Ruiz de Vergara Ruiz de Azúa)

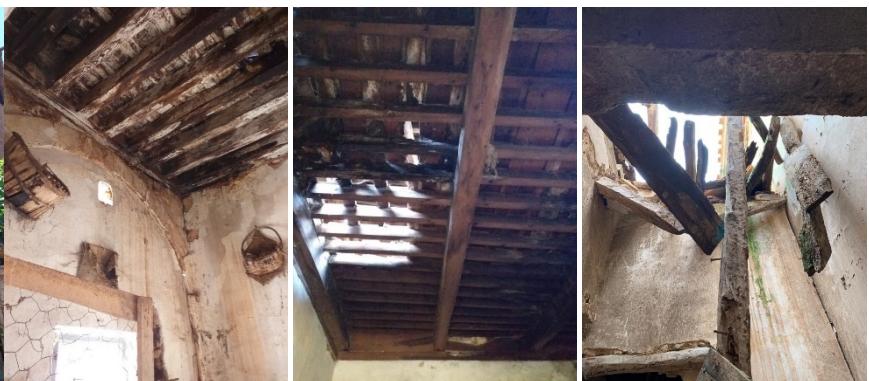
- The foundation is the extension of the walls themselves to the surface, and does not seem to present any problem, except for settlements in the Torreón area.
- deteriorated construction state of the slabs, although it seems that the supports are in good condition, which generates a serious threat of collapse of the roof structure,

the bell tower and part of the interior slabs (Fig.5).

Lack of resistance and rigidity capacity in some of the existing slabs due to the addition of masonry on them and, in general, for current regulatory requirements.

Fig. 5. Generalized deterioration of the slabs. (Source: Paula Montoya Saiz)

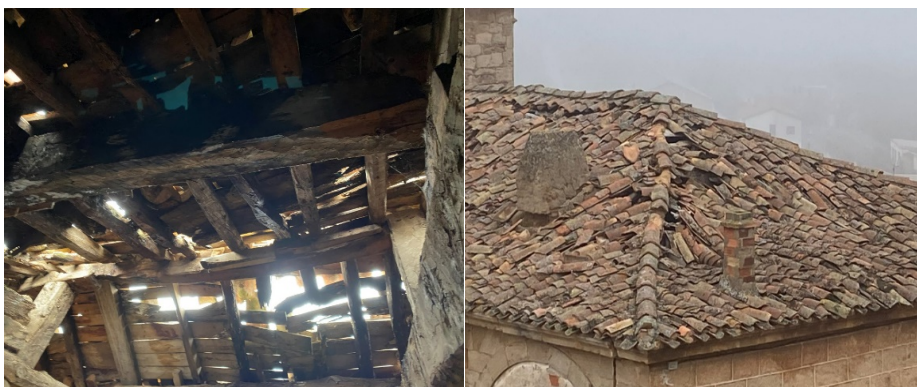
- Severe damage to the roof, where the loss of the tiles has caused collapses of some roof areas (Fig. 6), under the roof and first floor, allowing the permanent passage of rainwater and generating dampness in the walls. In July 2022, the roof structure of the Tower collapsed.

Fig. 6. Damage to the roofs. (Source: Paula Montoya Saiz)

2. Replacement of the roof: disassembly of tiles, shingles and purlins. Lifting and removal of wooden beams, cleaning of supports at the top of walls. Securing cornice pieces. Reconstruction of the roof structure with wooden trusses. Execution of new roof skirts using sandwich panel with thermal insulation, waterproofing and ventilated tile with aged finish. Gutters are not planned, but the traditional system of overflowing the cantilevered tile and the cornice as a drip is reproduced.

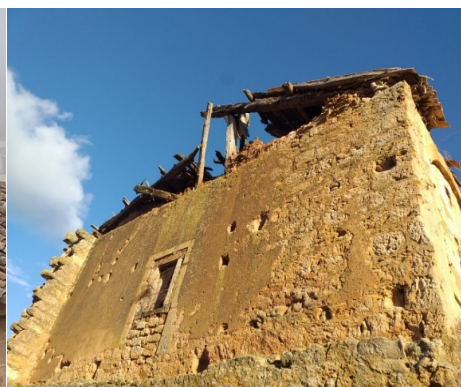
Cracks in the south and west facades, due to the deterioration of the masonry that have not been able to withstand the horizontal thrusts due to the collapse of the roofs (Fig. 7).

Fig. 7. Damage to the facades due to the collapse of the roofs (Source: Paula Montoya Saiz)

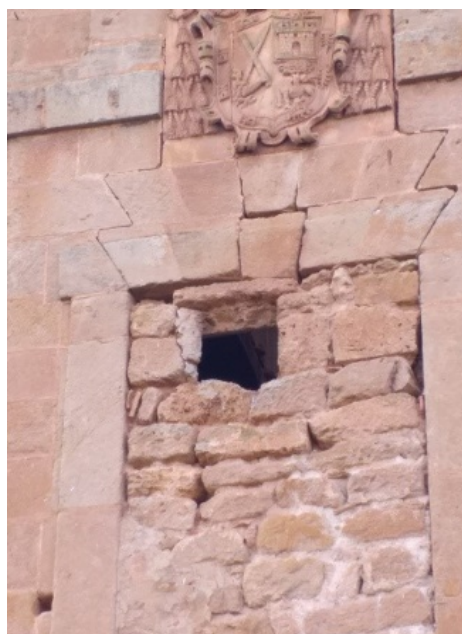
- Cracks in lintels, and alternations in façade openings in general, totally or partially blocked with masonry, brick or rammed earth masonry, as well as with added metal carpentry (Fig. 8). The façade openings of the upper body of the Tower have been vandalized and the voussoirs of the arches in the back of the central openings have been removed.
- Cracks and deterioration of the vaults of the main stairwell, lack of interlocking in its walls, and generalized vandalism (Fig. 9).

Fig. 8. Cracked lintel and blinded gap. (Source: Paula Montoya Saiz)

5. Tying of wall elements, lintels and arches, with special attention to the openings of the Tower, whose condition will be unknown until safe access can be

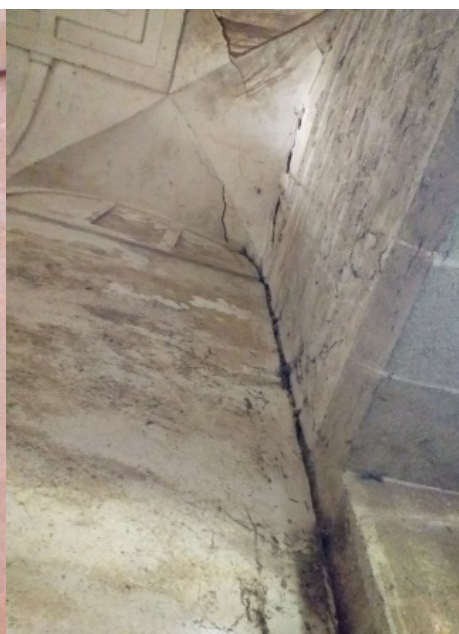
Fig. 9. Deterioration of the main staircase. (Source: Paula Montoya Saiz)

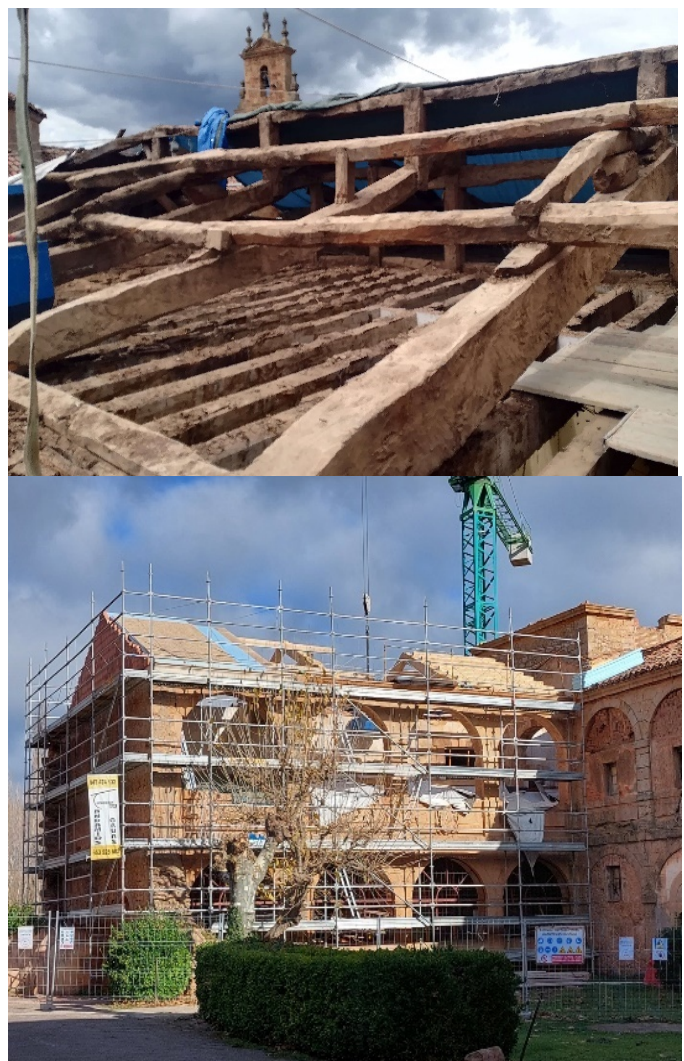
Fig. 13: Dismantling of the old roof and assembly works of the new one.  
(Source: Paula Montoya Saiz)

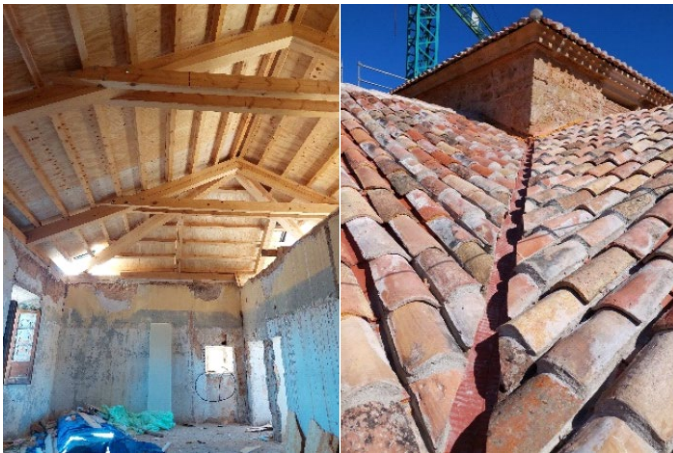
Fig. 16: Rehabilitation of the roofs. (Source: Paula Montoya Saiz)

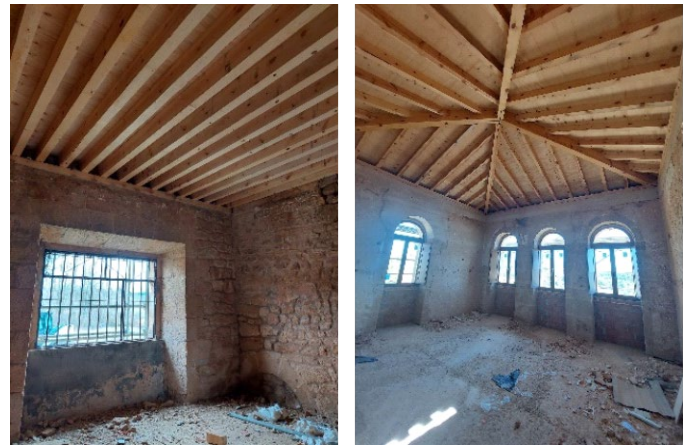
Fig. 17: Rehabilitation of the structure. (Source: Paula Montoya Saiz)

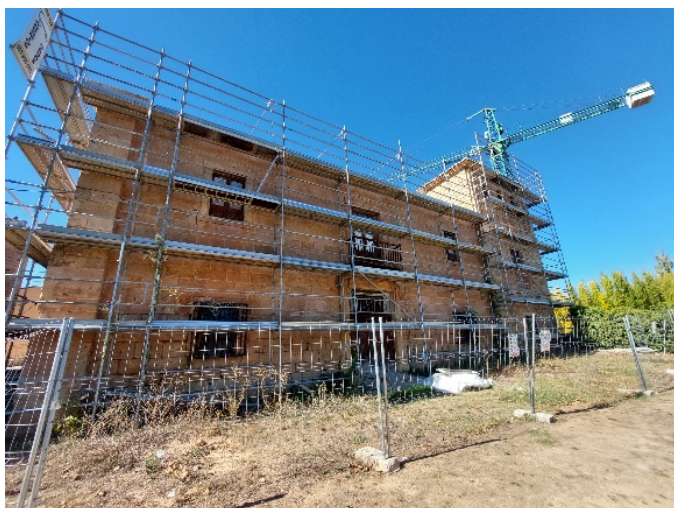
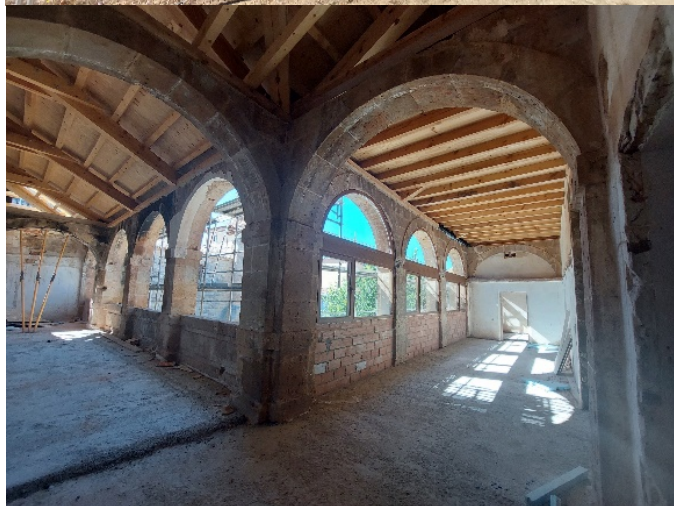
Fig. 18. Rehabilitation of walls. (Source: Paula Montoya Saiz)

- Cleaning and tying of walls, lintels and arches with stainless steel rods.
- Restoration of coats of arms and ashlar in poor condition, and topping with bastard mortar.
- Thermo-clay walls + 16 cm MW + ceramic lining, clad in lime biker.
- Cedar wood carpentry and double insulating safety and low-emission glass.

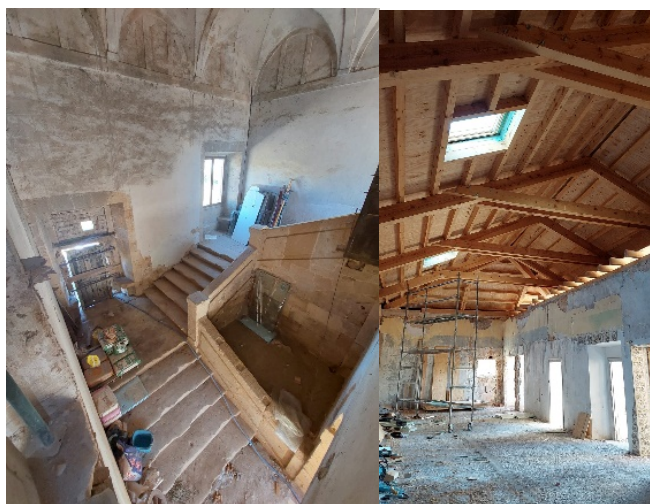
Fig. 19. Rehabilitation of interiors. (Source: Paula Montoya Saiz)

- Replacement of pieces of the main staircase with similar stone.
- Repair of plaster lunettes of the vault.
- Elimination of all elements inappropriate to the original construction.
