Anales de Edificación

Estudio y análisis de la problemática de los incendios durante el siglo XXI en grandes edificios patrimoniales de Valparaíso, Chile

Study and analysis of the problem of fires during the 21st century in large heritage buildings in Valparaíso, Chile

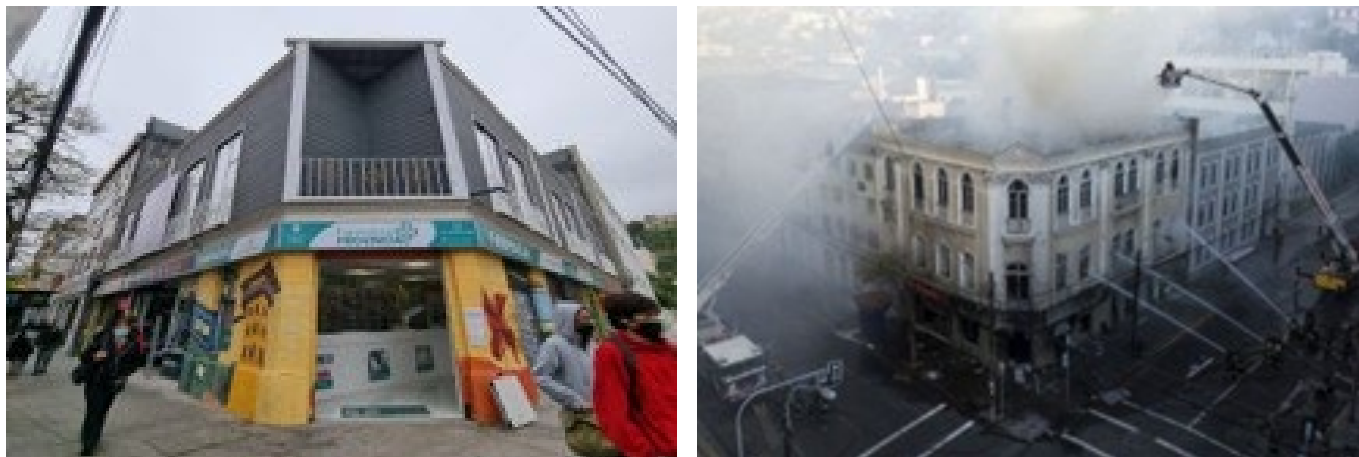
Fig. 2. Comparison of the property before the fire and after the fire. (Source: Left www.bbc.com. Right. Author, 2023).

An example is shown in Fig. 2, comparing buildings before and after fire reconstruction.
