Peter Blundell
Jones

Padley Mill

A question of interpretation

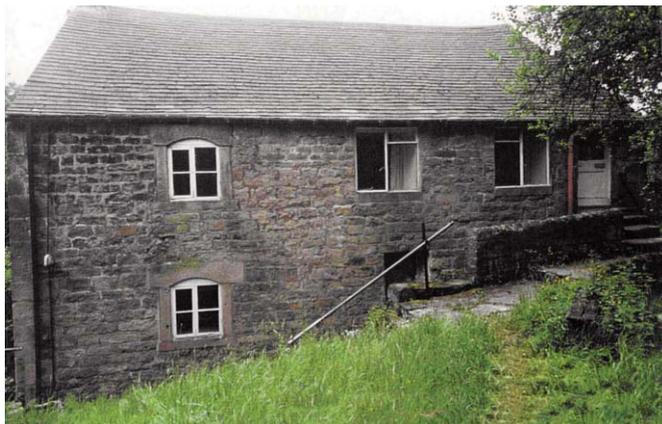
Right. Figure 9. North side as purchased in 1994.

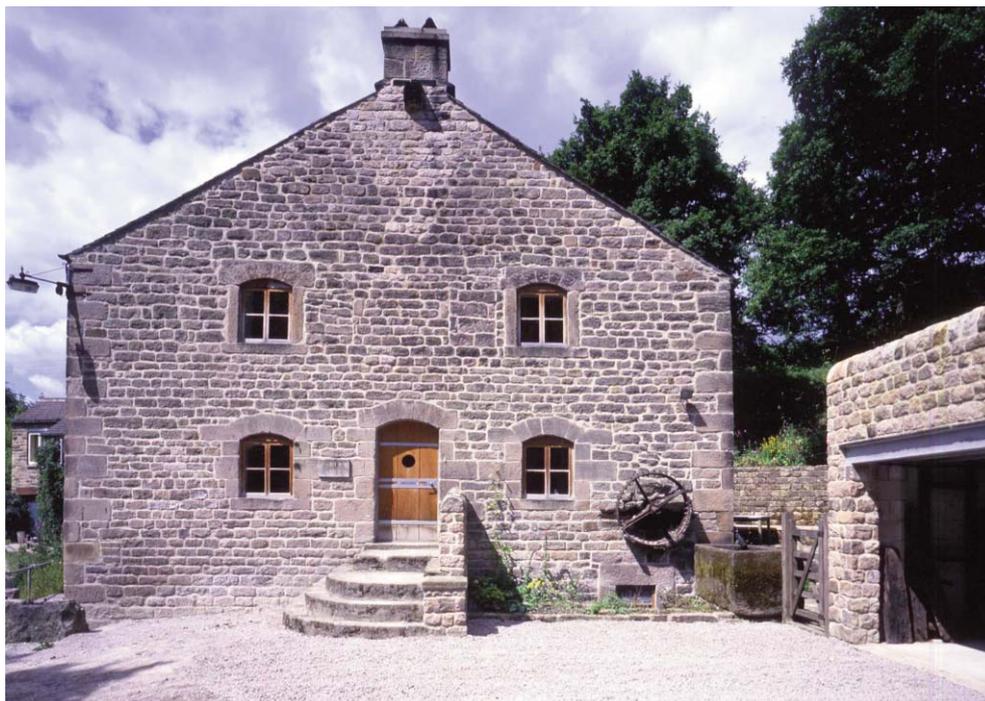
Figure 10. East front as restored, with added car port on right.

cing. The stonework showed that these were of at least three kinds suggesting layers of historic alteration (figure 10): the two on the lower east had true voussoirs, the five on the south and two on the north lintels cut as arches, the two upper ones on the east lintels with cut arches and fake voussoirs. On some jambs there were hinge pins to suggest a wooden shutter to cover only the upper half, but I have yet to see a surviving example of this type. The surviving softwood windows were single glazed and in poor condition, mostly sideways sliding sashes. We replaced all, but kept the two best originals for internal reuse. The new windows, made by a local joiner at the end of his career, were of oak with double-opening hinged casements,

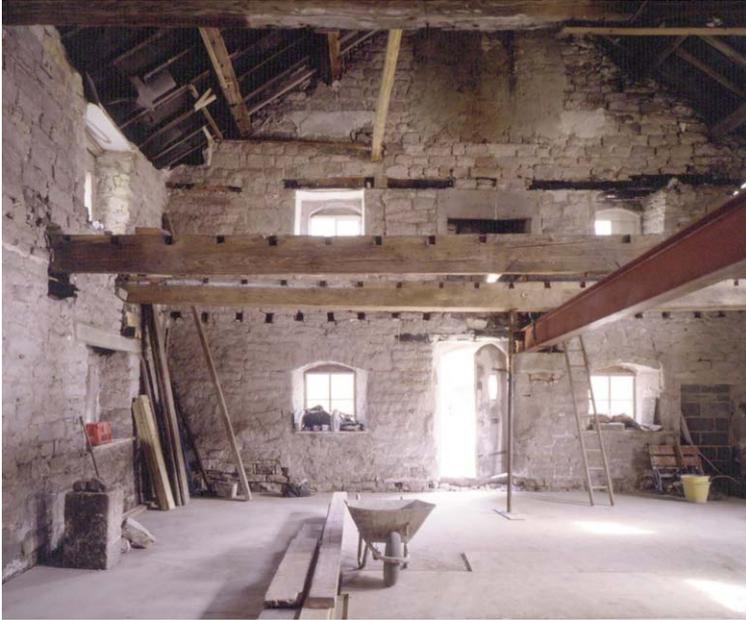
Figure 11. The building gutted for conversion with the new spine beam in place.

The main beams of 10 metre span had bowed, but could easily be relieved by adding a steel spine beam running longitudinally: this was accomplished on each intermediate floor with 30 cm steels to embrace the timber beams within the section so avoiding loss of height (figure 11). Since a spine beam for the upper floor would arrive in the centre of the front door if centrally placed, it was skewed to the side by 6°, the main reason for the introduction of a new plan angle further exploited in other ways. The rotten beam ends of the lower floor were repaired with bolted-on steel channels and concrete fill. The westernmost beam of the upper floor had been almost burned through in a fire and was perilously propped on single brickwork, so we replaced it with another bought as salvage. All the main beams were halved then tied into the steel spine beams with bolts and brackets. Potential heat loss through the 0.5m stone walls would have been considerable, so insulation was needed. Added outside, it would

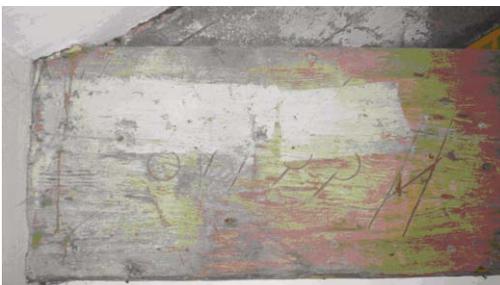
Left top. Figure 12. Importer's mark on truss.

spanning 10 metres. Each of these had circles and strokes inscribed on it which we took to be an importer's code (figure 12), as they were randomly placed on different faces. The roof on rough oak purlins was supported by two king-post trusses also of softwood, dividing the span into three bays between the gable walls, though low ceilings at tie level in the upper floor concealed the entire roof space. The inherited conversion offered little order or convenience, dividing the whole into small dark rooms with few windows at around 75 cm square. To carry out remedial work on the structure it was easier to remove it entirely.

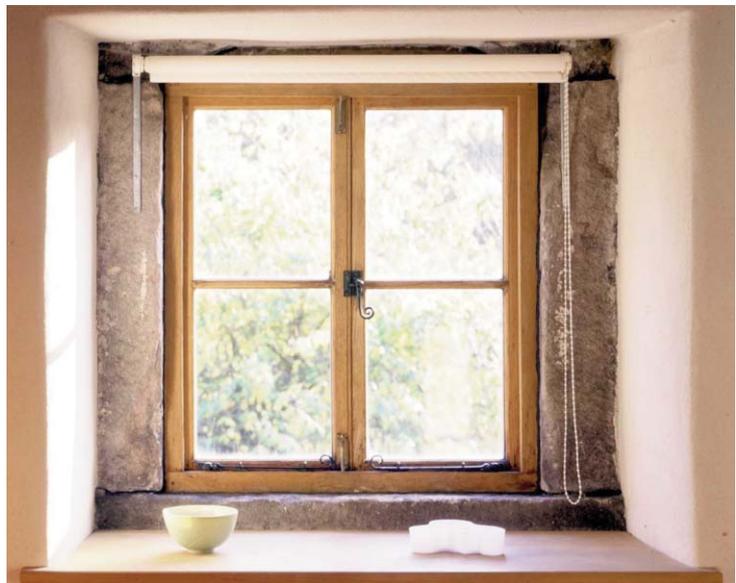
Right. Figure 14. New oak window, double outward opening, and deep reveal finished in silver sand render with beech cill.

have concealed the stone and contradicted the listing, so we decided to add a new skin of woodwool inside, fronting a cavity filled with recycled paper insulation. The woodwool panels were coated with an exposed lime-based and silver sand render to leave a continuous inside surface with good daylight reflection especially on the deepened window reveals, which we floored in light-coloured naked beech (figure 14).

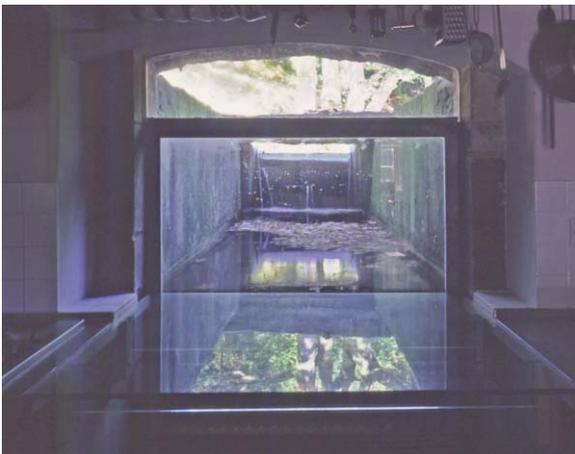
Left. Figure 19. Pentrough glazed.

panel on the end of the pentrough to preserve its opening and the view into it, and also to accept the full pressure of the dam if necessary. Later, when we had dug out the mill pond, we put a timber sluice between pond and pentrough which is now a waterfall visible from within the building (figure 19). We also fitted an old industrial valve to the pond's original inlet sluice to guard against flooding.
