Inspecciones en la gestión del agua de fachadas ventiladas basadas en la evaluación in situ y pruebas de laboratorio

Insights in the water management characteristics of rear-ventilated façades based on on-site assessment and laboratory testing

¹Maria Arce Recatalá; ¹Soledad García Morales; ²Nathan Van den Bossche

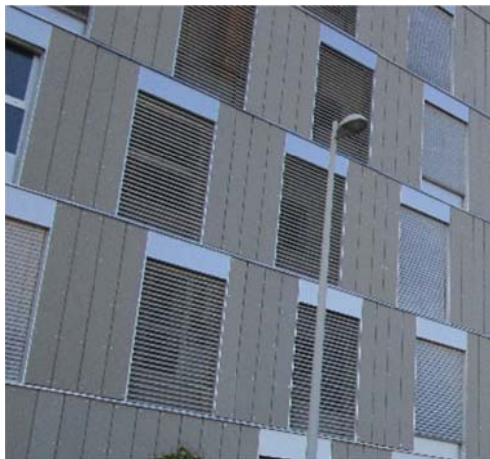
Fig. 3. Joint pattern of the façade.

The cladding is made of fibre cement panels in dark grey colour from slab to slab, whose size is 293 cm. tall, 34 cm. long and 0.8 cm. wide. These panels are arranged in the façade creating a grid of 7 cm. wide horizontal joints and 1.1 cm. wide vertical joints (see Fig. 3). The four edges of the panels are plane (see Fig. 4). The plane of the cladding is separated from the inner leaf (a brick masonry wall rendered with water-repellent mortar) 17 cm approximately, leaving an air cavity in between of 12 cm. including the width of the vertical profiles. The thermal insulation layer is made of 5 cm. thick fiberglass, which is covered by a weather resistant barrier.

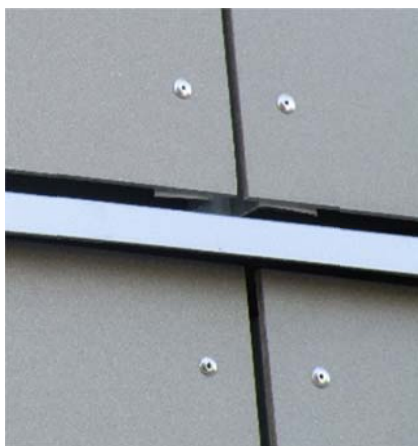
Fig. 4. Vertical and horizontal joint connection.

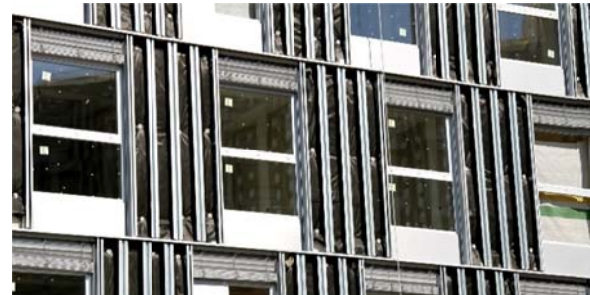
Fig. 5. Construction process of the façade.

The fiber cement panels are pointy attached to vertical omega profiles made of galvanized steel by means of stainless steel rivets. These fasteners are placed every 60 cm at both sides of the panel. The omega profiles go from slab to slab and are fixed to the brick masonry leaf by means of aluminum angle brackets. Behind each omega profile an aluminum horizontal profile is located, which is directly connected to the

slab edges by aluminum brackets (see Fig. 5).

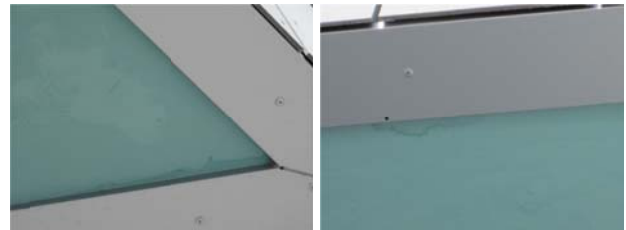
Fig. 9. Porch area during service life of the building.

have been identified during the inspection of the building. Nevertheless, despite the overall good water management characteristics of the whole façade, the drainage of the water infiltrated inside the air cavity has not been foreseen in the porch areas. In Figures 8 and 9 are shown some photos of the plinth: the one on the left was taken during the construction time and the two on the right some time later. In the latter, it can be seen the moisture stains appeared on the bottom surface when this water is not led outside.

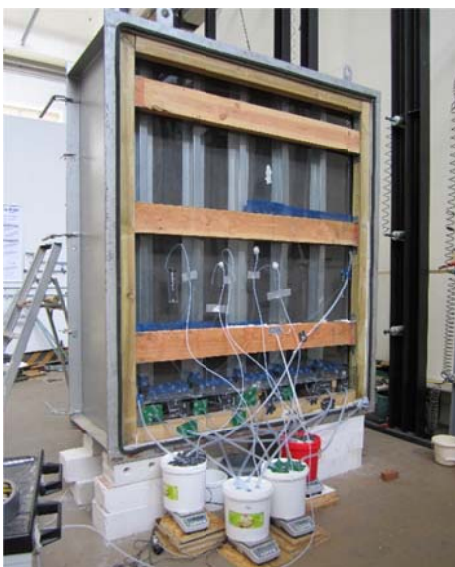
Fig. 11. Photo taken from the backside of the mock-up.

These gutters drained away the collected water to buckets, whose weight was recorded continuously over time (see Fig. 11).

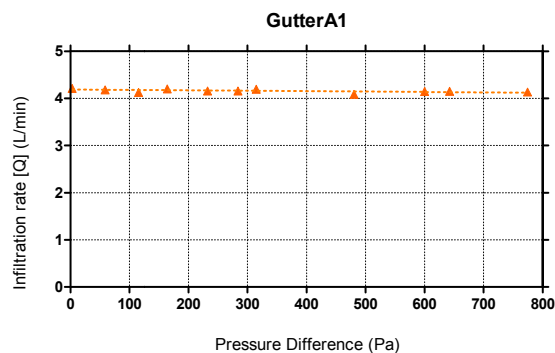
Fig. 12. Water collection rates measured in gutter A1 as function of applied pressure differences.

Figure 12 reports the infiltration rates in gutter A1 (runoff along the exterior surface of the panels, level I) as function of applied pressure differences in front of the cladding for a spray rate of 2 L/min per m². Constant water collection rates are recorded for increases in applied pressure differences, which indicates that the runoff film in level I is largely insensitive to the applied pressure differences in front of the cladding. All the measurements obtained are within the 95 - 105% confidence interval. The average obtained deposition rate is around 4.2 L/min, which implies that close to 93 - 94% of the collected rainwater creates the runoff film of the exterior surface of the cladding (level I).

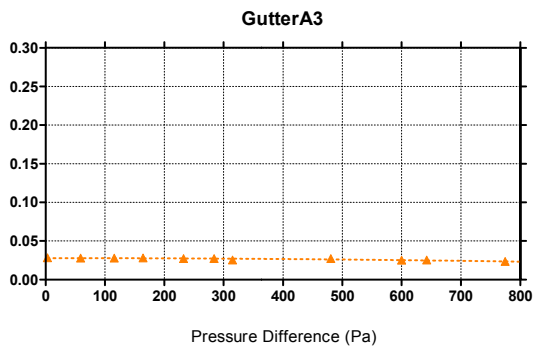
Fig. 14. Water collection rates measured in gutter A3 as function of applied pressure differences.

Figure 14 displays the water collection rates in gutter A3 as function of applied pressure differences in front of the cladding for the spray rate of 2 L/min per m². This gutter gathers the water flowing down inside the air cavity (levels IV and VI). It is the water infiltrating not only through the gaps of the screws, which fixed the vertical profiles to the brackets, but also through the contact surfaces between the panel and the wings of the omega profiles (see Fig. 16). It seems that water entry rates are constant for rising pressure differences. Apparently, the water drained along the capillary pathways between the panels and the omega profiles is not necessarily influenced by the applied pressure differential step. Nevertheless, this time, 90% of the measurements obtained are within the 95 - 105% confidence interval. An average value of 0.026 L/min of water infiltrated inside the air cavity, which

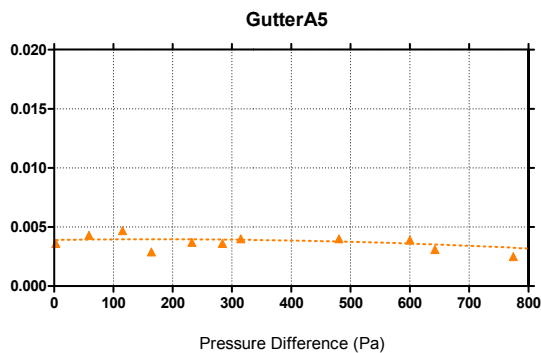
Fig. 15. Water collection rates measured in gutter A5 as function of applied pressure differences.

Finally, figure 15 shows the water collection rates in gutter A5 in relation to the applied pressure differences in front of the cladding. The stagnant water (capillary water) between the contact surfaces of the panel and the omega profiles, and within the gaps of the rivets splashes onto the PMMA sheet (level VII) when certain pressure differences are applied over the cladding (see Fig. 17). Note that in this case, the scale of the “y” axis in the graph is around 100 times smaller than in the case of gutter A1. In this instance, more dispersion among measurements within applied pressure differentials were obtained. Only 50% of the measurements obtained are within the 90 - 110% confidence interval. Unlike expected, around 0.004 L/min of water reached the exterior surface of the PMMA sheet, which means from the 0.04 to 0.1% of the total amount of collected rainwater.
