## Estudio de la durabilidad de Hormigones y Morteros reforzados por residuos industriales (Fibras Metálicas)

### Study of the durability of Concretes and Mortars reinforced by industrial waste (Metallic Fibers)

Souad Kherbache, Abdelkader Tahakourt, Karim Moussaceb, Nedjima Bouzidi

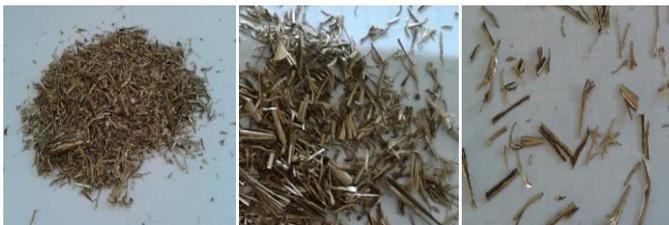
Fig. 1. The fiber chips used in this study.

These fibres are 0.5 to 1 mm thick and 0.2 to 1 cm in length and are CuZn40Pb2 type. Their characteristics are given in Table 1.

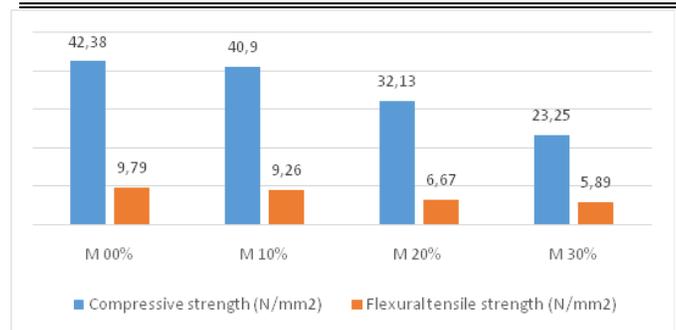
Fig. 2. Evolution of the flexural and compressive strength at 28 days of mortars according to the percentages of fibers added in substitution of the cement study (Kherbache, 2018 ; Kherbache et al., 2016).

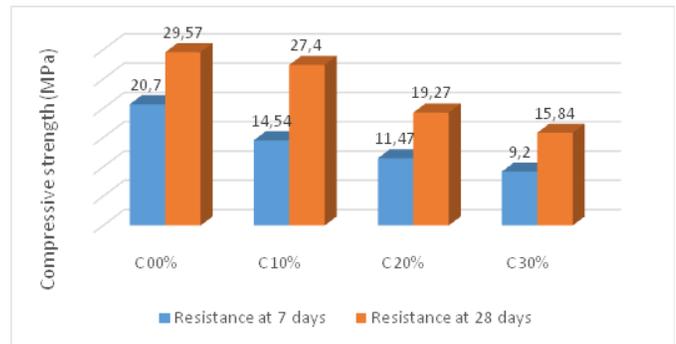
Fig. 3. Evolution of the compressive strengths of concretes with fibers in substitution of the cements study (Kherbache, 2018 ; Kherbache et al., 2016).

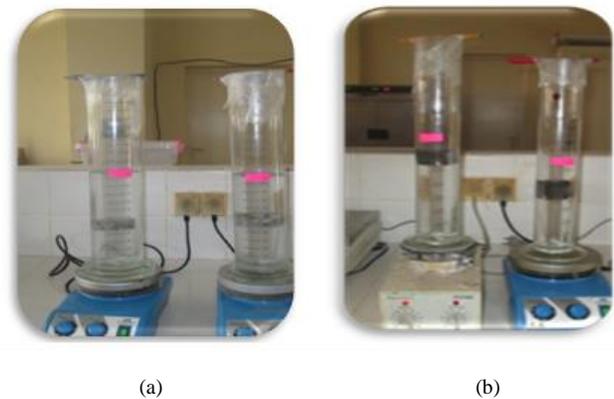
Fig. 4. Leaching device: a) On concrete disc; b) On cube of mortar.

The waste leaching test is currently considered, as an indispensable tool for predicting the long-term behaviour of stored and / or recovered waste (Imyim, 2000). It consists of characterizing the transfer mechanisms by observing the fluxes of chemical elements, released by porous monolithic blocks of known dimensions. The block is contacted with a fixed volume of leach solution. The solution is renewed periodically and the dynamics of the release of certain elements is determined by the physicochemical analysis of the obtained eluates (Environment Agency, 2005; Conner, 1990). The experimental device is shown in Fig. 4.

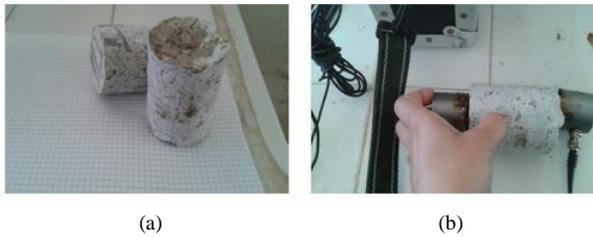
Fig. 6. Evaluation of the compressive strength by sonic auscultation: a) Minicylinders 5x10cm. b) Measurement of the propagation speed

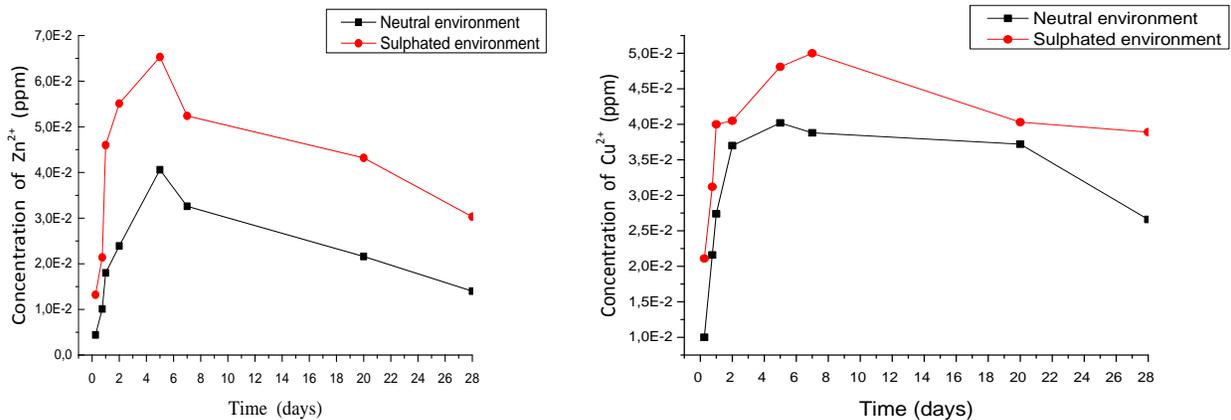
Fig. 7. Evolution of zinc and copper concentrations in mortars.

All the curves (Fig. 7 and Fig. 8) of the release of the chemical elements contained in the mixtures of concretes and mortars have the same appearance, there are two (02) stages:

The 1<sup>st</sup> stage where there is an increase of the release until the age of 5 days, it can be explained by the swelling of the monoliths and consequently an increase of release of these metals. The 2<sup>nd</sup> stage where there is a decrease in the release from the 5th day, it can be explained by the depletion of the metals that are on the surface of the monoliths. The obtained

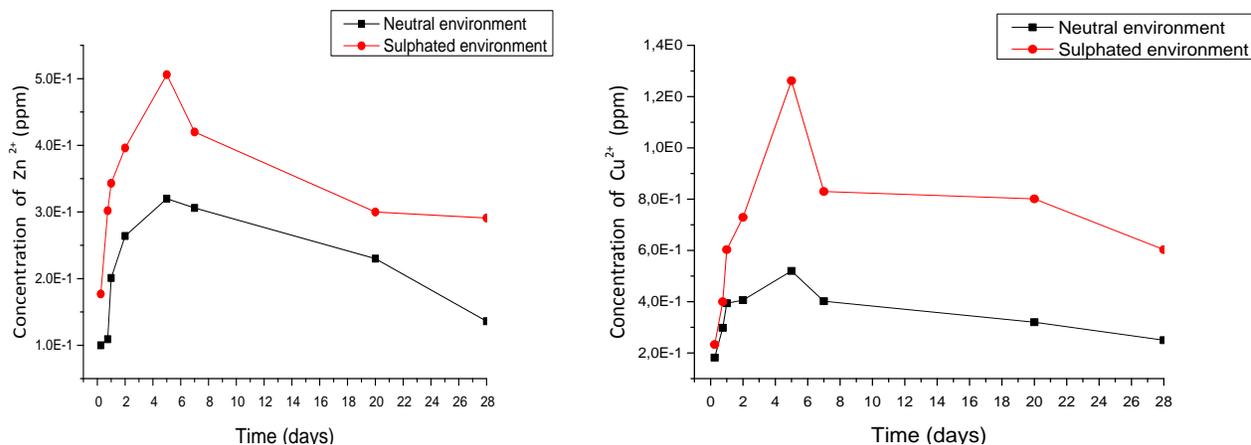
Fig. 8. Evolution of zinc and copper concentrations in concretes.

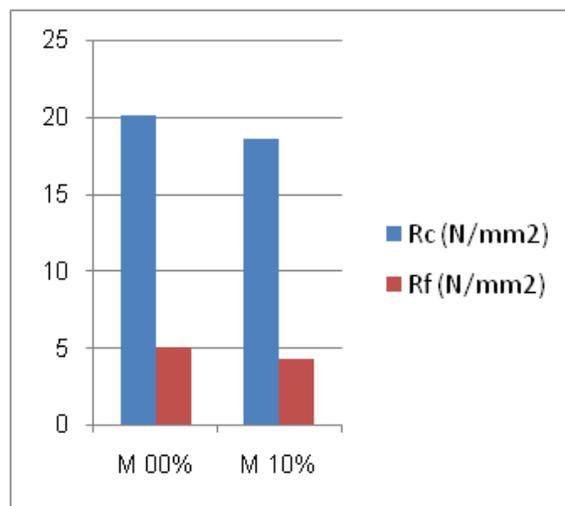
Fig. 11. Loss of resistances of mortars subjected to the immersion/drying

the mechanical strength and the mass variation of the mortar prisms, containing 10% of fibres in substitution of the cement during this aging test (Fig. 11 and Fig. 12).

For both mortars the mechanical strengths are relatively low, compared to the initial resistances before the test. This diminution is more important for the mortars with 10% of fibres that amounts to the porosity existing in the specimens with fibres base. Mortars with dry wetting cycles lose their mechanical performance and this loss is even greater in fibre mortars. These explanations are also suitable for the loss of mass of these mortars subjected to the aging cycle, such that the loss of mass has the same variation as the loss of resistance. The presence of fibres creates a preferential path for the departure and absorption of water.

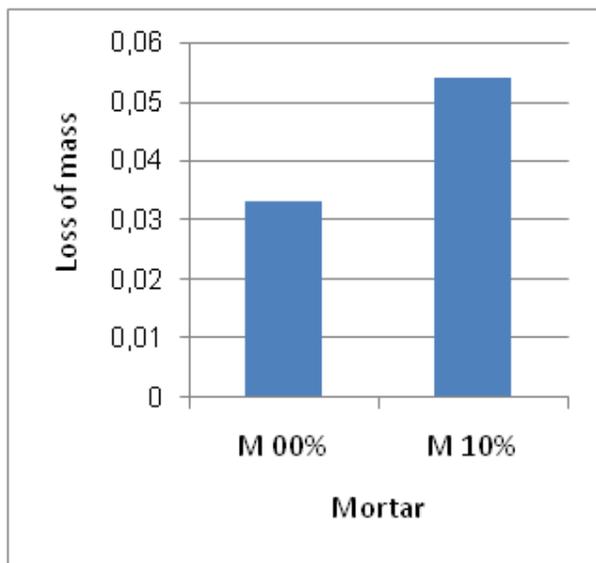
Fig. 12. Loss of mass of mortars subjected to the immersion/drying cycle.

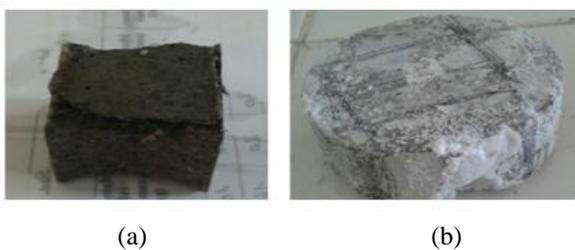
Fig. 13. Samples after sulphate attack. (a) Mortar. (b) Concrete.

and concretes. In our sulphate attack tests, it was noted that mortars are more prone to deteriorate compared to concrete specimens (large expansion of mortars). Figure 13 clearly illustrates this phenomenon. This this mainly comes down to the initial composition of these mortars and concretes, as they contain aggregates that slow down the phenomenon of degradation. If we compare the effect of the attack on the control mortars and the mortars with 10% of fibres in substitution of the cements, the latter are more resistant (less expansion and without cracks) (Fig. 14) and this although the porosity is slightly important in the mortars with fibres. Sulphates react directly with the cement paste, that is to say less cement, less sulphate-cement reaction and less expansion.

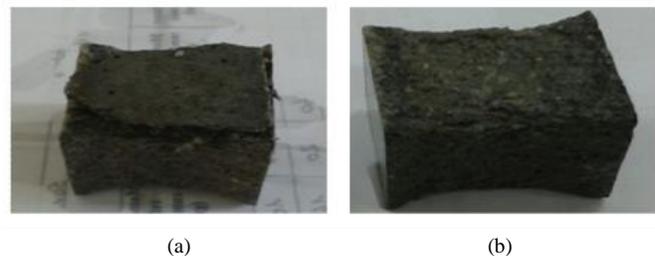
Fig. 14. Degradation of the mortars in the sulphated medium (5% Na<sub>2</sub>SO<sub>4</sub>, 10H<sub>2</sub>O): (a) Control Mortar. (b) Mortar with 10% fibers.

The crystals of ettringite and calcium sulphate accumulate in the matrix cement, producing internal pressures which generate cracks. Thus, the use of the 10% fibres in cement substitution has a beneficial effect on the durability of the concretes with respect to concentrated sulphates at 5%. The degradation of mortars by sulphates is particularly related to the formation of

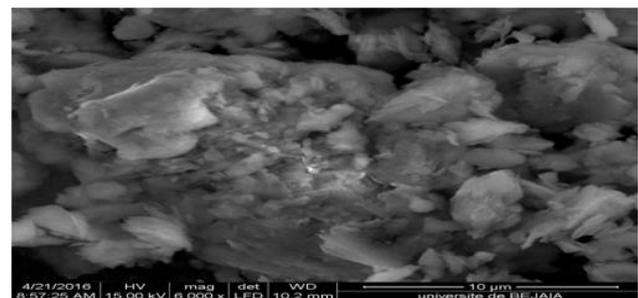
Fig. 15. SEM photo of Portlandite and CSH in the mortar.

The existence of the NaOH element is the main cause of the alkalinity of our storage solutions which stabilizes the C-S-H crystals (Fig. 15). The presence of CaSO<sub>4</sub>, 2H<sub>2</sub>O makes our samples more expansive (Gagne, 2004). This is consistent with the XRD analysis of our mortars subjected to sulphated attack (Fig. 16).

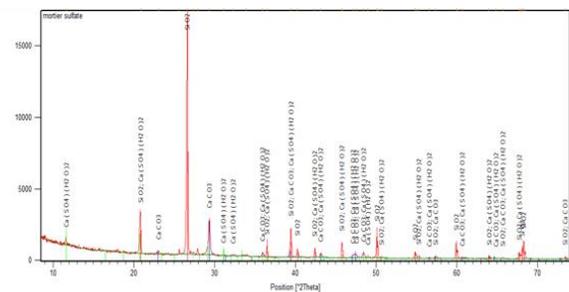
Fig. 16. XRD spectra of mortar with 10% fibers subjected to 5% Na<sub>2</sub>SO<sub>4</sub> attack.

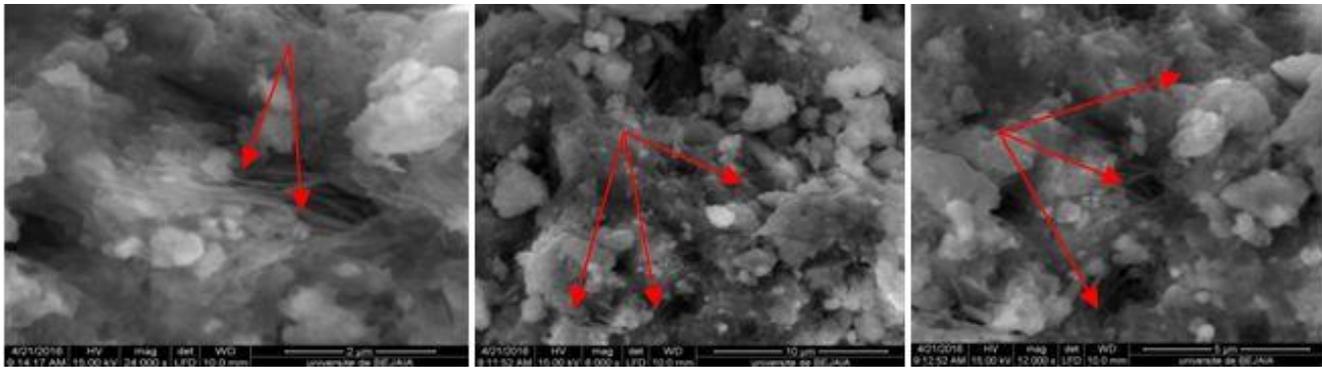
Fig. 17. Secondary ettringite in the control mortars.

In order to confirm the origin of the expansion and to deepen our study, we used the scanning electron microscopy of reference mortars (0% fibre), (Fig. 17).

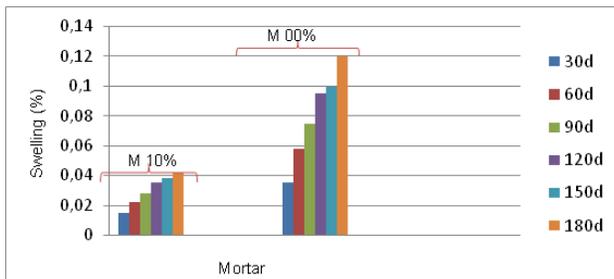
Fig. 18. Evolution of the expansion of the cubes of mortars preserved in the solution of 5% Na<sub>2</sub>SO<sub>4</sub>.

The study is continued by measuring the swelling undergone by the mortar (Fig. 18).

In addition to visual observations, the expansion measurement results clearly show the increase in swelling (weight gain) as a function of the age of storage, in the sulphated solution up to 180 days. This gain is attributed to the formation of gypsum and secondary ettringite, following the reaction between the hydrates and particularly the portlandite and sulphates of the solution. Sulphates cause swelling by reaction with tricalcium aluminate (Baron and Ollivier, 1997) which generally increases the rate of concrete degradation (Zayed, 2004). If one analyses the values of the swellings, obtained during the expansion of our mortars in the solutions of the sulphates, one can classify the different behaviours with respect to the swelling according to the work achieved by Brunetaud (Brunetaud, 2005), as follows:

The expansion of the reference mortars (M00%) varies from 0.035 to 0.12%, between 30 and 180 days, the expansion remains less than 0.2%, so the swelling is considered low. For

mortars with 10% fibres (M10%), the expansions are of the order of 0.015 (30 days) to 0.042% (180 days), these values are much lower than the limit value 0.2%, so the swelling is also considered low. The fibres contained in the mortars have not reacted with the sulphates of the solution (according to the XRD), otherwise further analysis (ESM-EDS) would be needed to confirm.

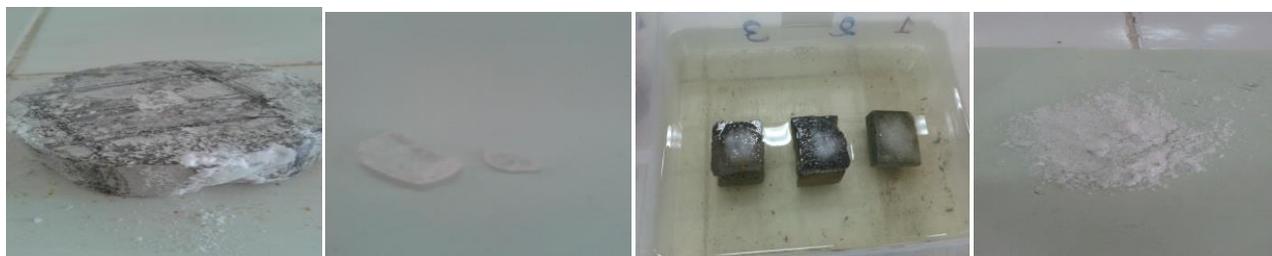
Fig. 19. Material formed on samples during sulphate attack.

The white powder layer formed on our samples of long-term concretes and mortars during this sulphate attack (Fig. 19) is analysed by XRD. The phase determination of the layer thus formed show that they are hydrated sulphates (Fig. 20).

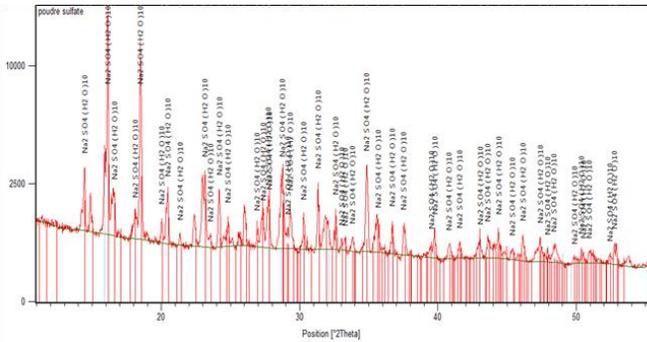
Fig. 20. XRD spectra of the sulphate powder.

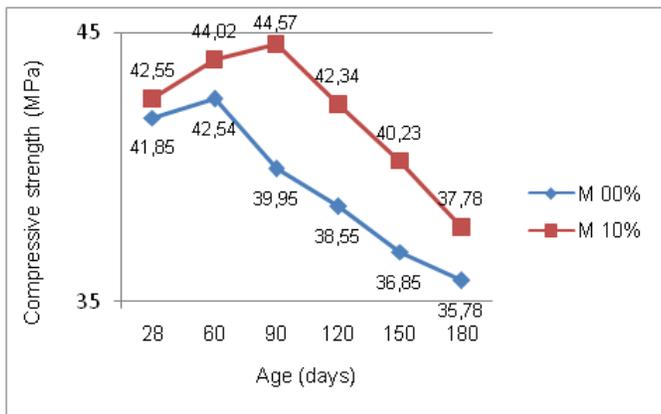
Fig. 21. Compressive strength of mortars preserved in sulphates as a function of time.

The results of compressive strengths of the mortar cubes kept for 6 months in the 5% Na<sub>2</sub>SO<sub>4</sub> solution are shown in Fig. 21.

The curves look the same. The variation of the compressive strength of the cubes of mortars was not in the same step of the expansion. The M00% samples develop their resistance until the age of 60 days. Exceeded this age, the samples lose their resistance, the thing that was predictable since the expansion was relatively high. In addition the reaction between portlandite (Ca(OH)<sub>2</sub>), resulting from the hydration of cement with sulphates, to form gypsum and expansive ettringite causing microcracks that lead to the fall of resistance. For the M10% samples, the resistances are slightly better compared to those of the reference mortar. The compressive strengths increase as a function of time until the age of 90 days and then a resistance

loss is noted ranging from 44.57MPa (90 days) at 37.78MPa (180 days). The reason can be attributed to the early age resistance of these samples to this aggressive environment. This phenomenon is also attributed to the presence of fibres. It is possible that crystals of copper sulphates and zinc sulphates have formed, according to the following reactions:

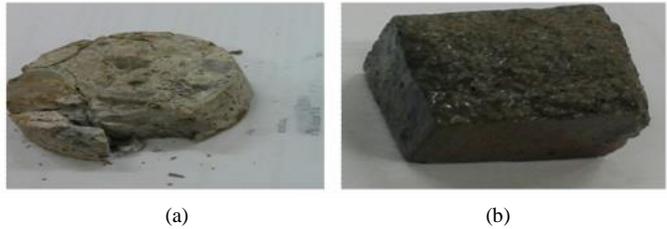
Fig. 22. Degraded state at 45 days of acid attack: (a) Mini-cylinders of concretes. (b) Cubes of mortars.

After 45 days of attack, the samples are too damaged and continuity of measurement is not possible. If we compare the specimens of reference with those of 10% of fibres in substitution of cement, one notes that their degradation is not really different. The copper contained in our fibres is not attacked by hydrochloric acid (Fig. 23).

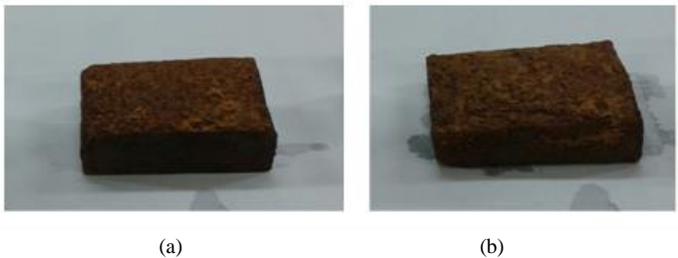
Fig. 23. Mortar after 45 days of attack: (a) Control Mortar. (b) Mortar with 10% fibers.

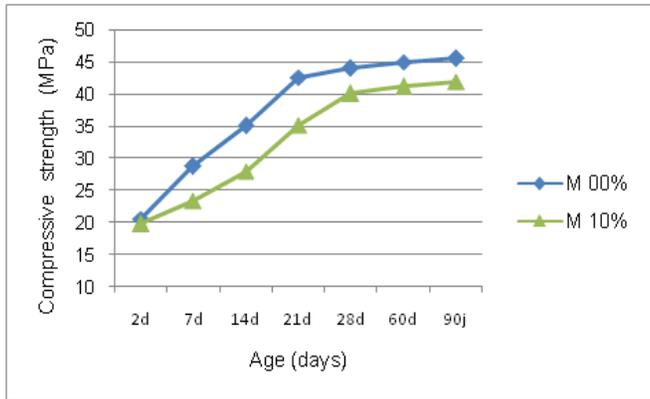
Fig. 29. Evolution of the compressive strength of mortars kept in water as a function of time.

The compressive strength tests on the mortar cubes gave a significant increase in mechanical compressive strength as a function of time (Fig. 29).

This gain in resistance is attributed to the phenomenon of maturation of the cement matrix. The presence of water in the porosity of the sample favours the displacement of Ca<sup>++</sup> ions and thus the crystalline growth of portlandite. The latter is transformed into calcite which also explains the resistance gain that has been recorded. The reference samples have a better resistance, compared to those of 10% of fibres in substitution of cement that amounts to the reduction of the compactness of the latter. SEM analysis were performed, observations made on the samples mortars provide information on the homogeneity of their morphology (Fig.30).

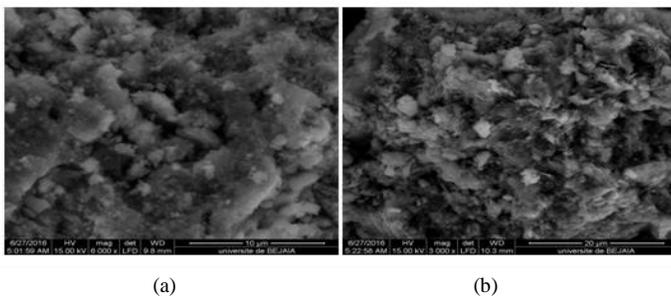
Fig. 30. SEM photo of the samples mortars: (a) Mortar with 10% fibers. (b) Reference mortar (0% fibers).

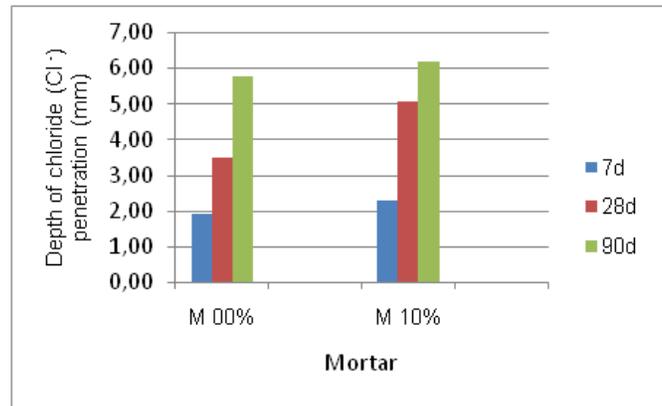
Fig. 31. Depth of penetration of Cl<sup>-</sup> ions.

The depth of chlorides penetration as a function of time is shown in Figure 31.

The penetration depth of the chloride ions of mortars at 10% fibre is higher than that of the reference mortars in the three deadlines. This is mainly due to the permeability of fibre-based mortars which is slightly larger. This infiltration increases with time. If we analyse the rate of variation of the crossing of chloride ions for the two types of mortars, the elevation of the depth is of the order of: 1.19%, 2.19% and 3.62% respectively at 7, 28 and 90 days, for reference mortars, and 1.44%, 3.19% and 3.87% for 10% fibre mortars. However, the depth of chloride penetration is important as a function of time.
