Anales de Edificación

Eficiencia energética en edificios municipales de Argentina para el programa euroclima+ Energy efficiency in municipal buildings in Argentina for the Euroclima+ program

Resumen-- En el marco del programa Euroclima+ se han realizado auditorías energéticas en edificios municipales de Argentina. Para estudiar los edificios se ha utilizado información suministrada por los municipios e información recolectada por los auditores. Luego, se elaboró un programa que permite obtener resultados de demanda de energía según la metodología de la normativa nacional IRAM. A partir de ello se ha encontrado que los edificios no reúnen condiciones adecuadas de confort higrotérmico a pesar de consumir mucha energía. Con las mejoras propuestas se alcanza una reducción de la demanda de energía de al menos un 40%.

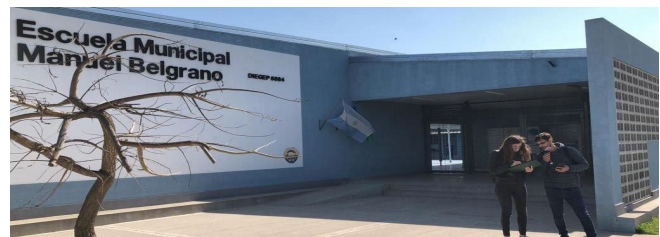
Fig. 2. Building access

The windows are aluminum-framed, without a thermal break, weatherstripping, and single-pane glass. Some have sunshades, while others have eaves. The adopted thermal transmittance coefficient (K) is 5.82 W/(m²·K). The doors are made of double-paned steel ($e = 0.9$ mm each) and are 5 cm thick. The calculated thermal transmittance coefficient (K) is 3.57 W/(m²·K).

The lighting system consists of LED fixtures. The heating system runs on natural gas. It is distributed through diffusers connected by a network of ducts. There are seven Goodman boilers, model CAPF 363686. In summer, fans, a split-type air conditioning unit, and a Goodman refrigeration unit coupled with a CAPF 363686 unit are used. During January (summer), the building remains closed.

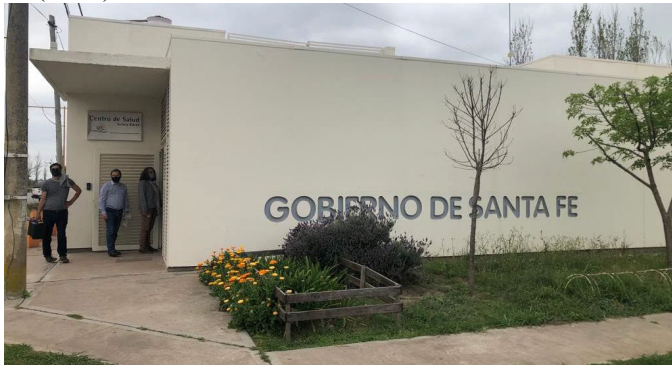
Fig. 5. Building access

Regarding the building envelope, the roof consists of 20 cm thick reinforced concrete slabs and a 12 cm lean concrete subfloor with a liquid waterproofing membrane on the exterior. Inside, a 2 cm thick plasterboard ceiling suspended 50 cm from the slab can be seen. The ceiling height is 2.70 m, and 4.20 m in the consulting and nursing rooms. The calculated thermal transmittance coefficient K is 1.01 W/(m²·K) in winter and 0.94 W/(m²·K) in summer.

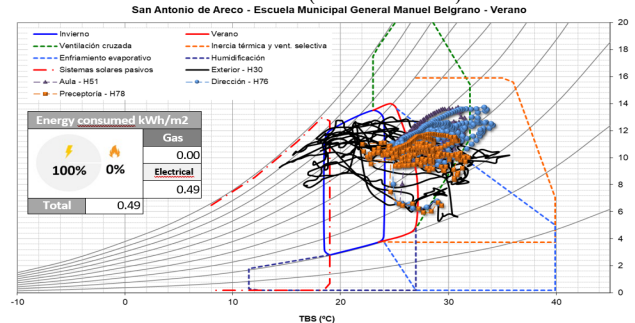
For this building, it was found that, both in winter and summer, it operates most of the time outside the hygrothermal comfort zone, despite the energy consumption that maintains interior temperatures. The following improvements were proposed:

Fig. 11. Psychrometric diagram and energy consumption. Summer measurement. (Source: Authors)

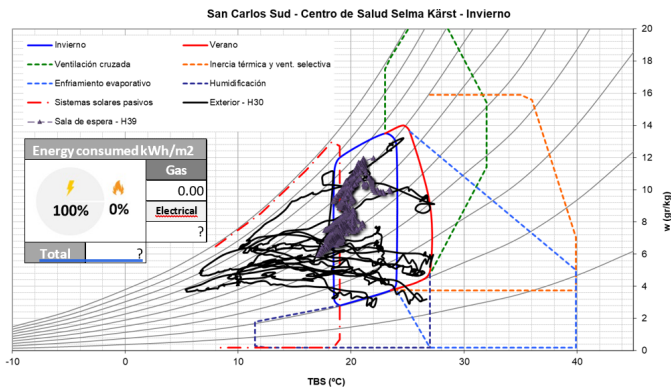
Fig. 14 were obtained from temperature and humidity measurements taken using sensors located in the waiting room and outside between September 30, 2021, and October 14, 2021.

It can be observed that this building exhibits improved hygrothermal behavior. This behavior is possibly due to the inertia of the walls. Gas consumption is zero since it has no gas supply. Improvements shown in Fig. 12 were proposed.

Fig. 14. Psychrometric diagram and energy consumption. Winter measurement. (Source: Authors)

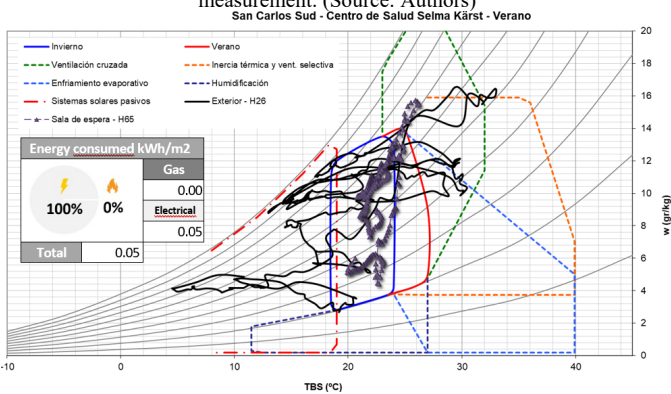
From measurements taken at the same sites, between 3/24/2021 and 3/31/2021, Fig. 15 was obtained.

Fig. 15. Psychrometric diagram and energy consumption. Summer measurement. (Source: Authors)
