## Proyecto de rehabilitación para uso residencial de la antigua abadía de salas de Bureba (Burgos) Rehabilitation project for residential use of the old abbey of salas de Bureba (Burgos)

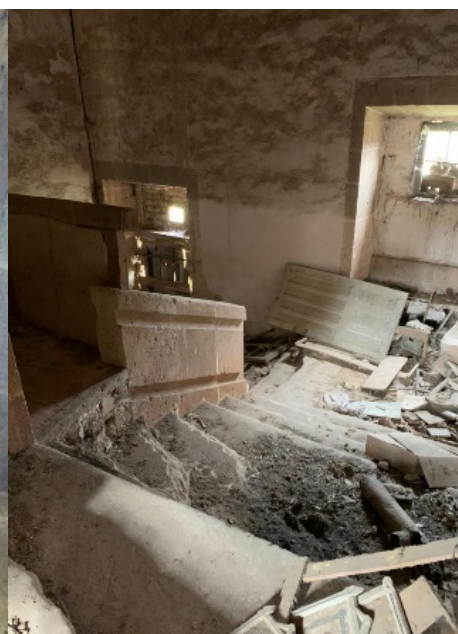
- Cracks in lintels, and alternations in façade openings in general, totally or partially blocked with masonry, brick or rammed earth masonry, as well as with added metal carpentry (Fig. 8). The façade openings of the upper body of the Tower have been vandalized and the voussoirs of the arches in the back of the central openings have been removed.
- Cracks and deterioration of the vaults of the main stairwell, lack of interlocking in its walls, and generalized vandalism (Fig. 9).

Fig. 9. Deterioration of the main staircase. (Source: Paula Montoya Saiz)
