Anales de Edificación

Estudio y análisis de la problemática de los incendios durante el siglo XXI en grandes edificios patrimoniales de Valparaíso, Chile

Study and analysis of the problem of fires during the 21st century in large heritage buildings in Valparaíso, Chile

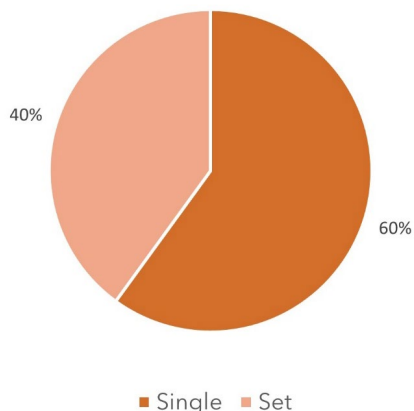
Fig. 6. Entity of the fires, type of impact, individual or collective.

From the graph in Fig. 6, it is observed that 60% of the constructions, corresponding to 18 buildings, had individual damage without propagation to other properties, while 40% of them did spread to other buildings, resulting in a larger-scale fire and consequently the loss of more than one building.

Of all the properties with individual damage, amounting to 18 cases, 11 experienced either total interior loss or total loss of the property.

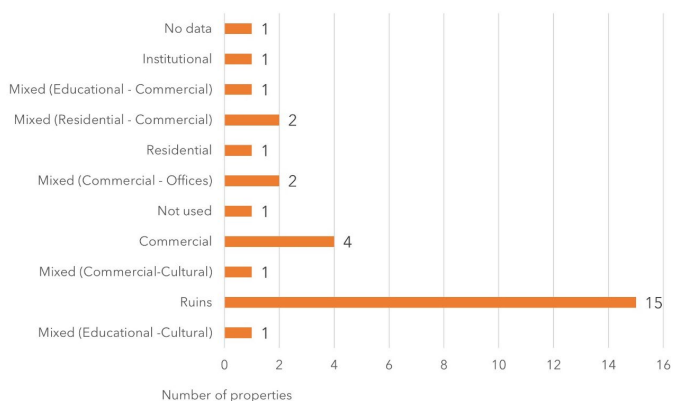
Fig. 8. Uses of the properties after the fire

On the other hand, to assess possible changes resulting from the fires, data on the "Use of properties after the incident" have been collected. It can be observed from Figure 8 that 50% of the fire-affected properties have lost their initial architectural program, remaining in ruins after the incident.
